Acca Yard Bypass 15% Interim Design Report

15% Interim Design Report

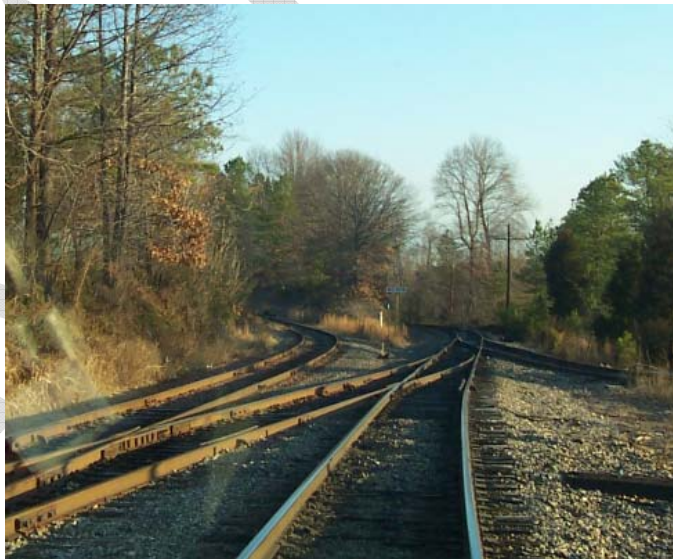
Between about MP 88.7 to about MP 89.5, the existing track is located on the edge of a steep cut with a steep embankment on the north side (geographic east). After MP 89.0, there are 3 locations where the existing embankment appears to be severely eroded from the outfall from existing cross drain culverts. One area appears to be further damaged from a previous derailment. The 15% design assumes embankment improvements with rip rap in these areas.

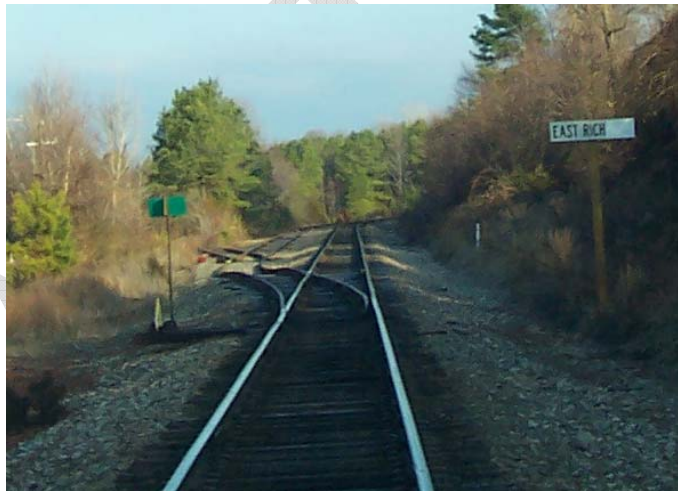
The siding is an expansion of the existing siding between MP 92.3 and MP 92.7. Lengthening the siding eastward to MP 91.9 provides the 'tail' room for switching the industry at MP 92.4. The tail room provides space for the local train to pull cars out of the industry's track without going onto the single main.

The siding expansion westward to MP 93.2 takes an industrial track switch that is currently on the single main and shifts it to the siding. This allows the local to switch the industry without using the single main track.

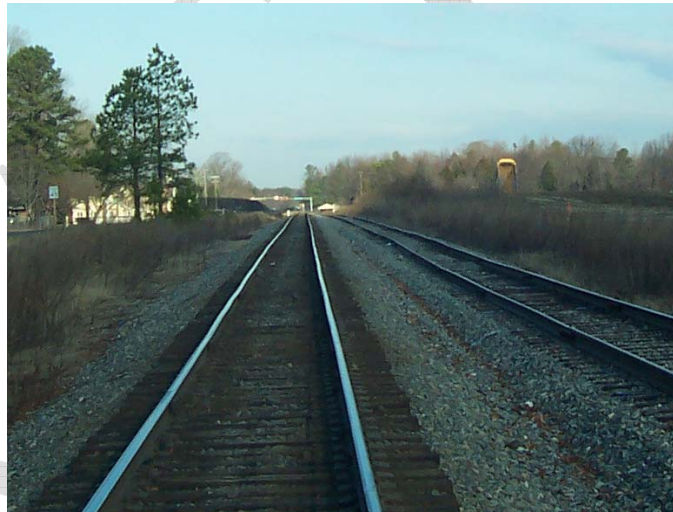
This siding is an expansion to the west of the existing siding between MP 93.5 and MP 94.4.

This siding is considered as a potential location for the proposed multi-modal transportation center.

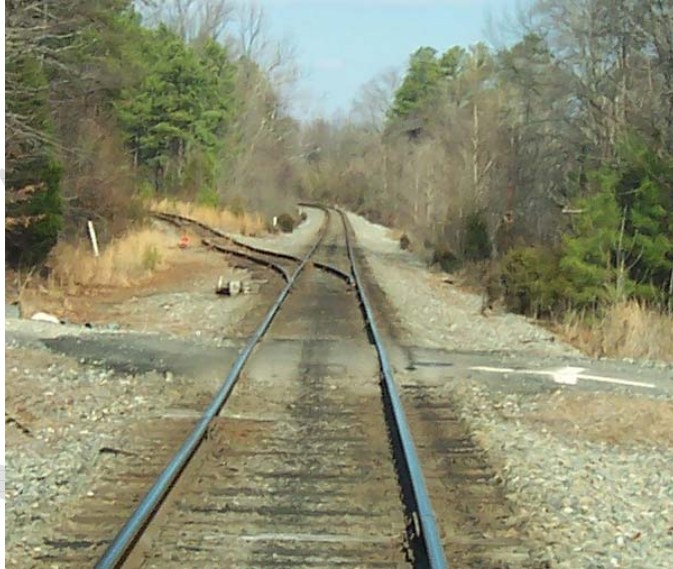
This 2,000 foot passing siding is envisioned as a location where the local freight train can clear the single main to allow through trains to pass while allowing the local to switch the industry located on the siding.

The siding is a new siding that will provide 'tail' room for switching the industry at MP 92.4. The tail room provides space for the local train to pull cars out of the industry's track without going onto the single main.

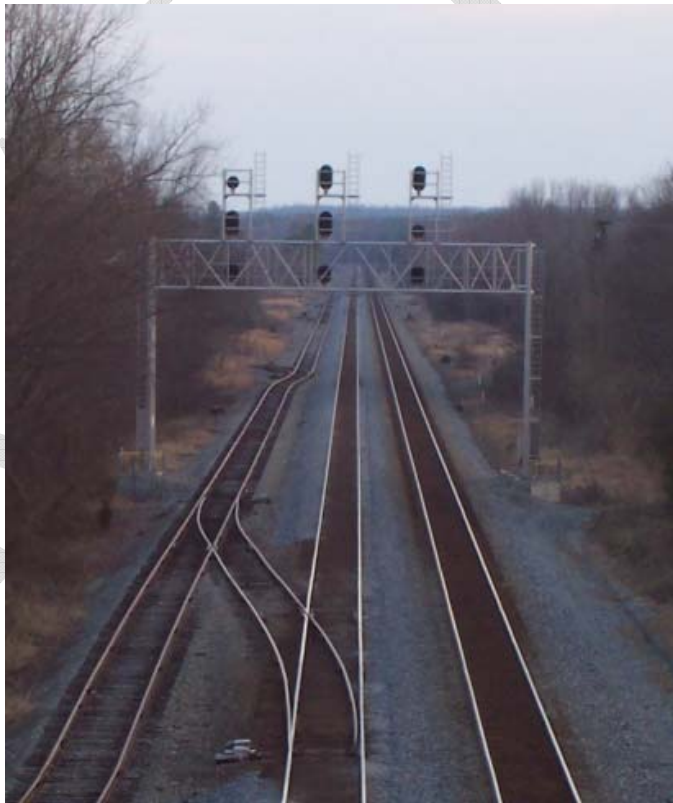
The Milford Passing Siding is located on the east side of the RF&P Mainline. It utilizes portions of the existing industrial switching lead at Milford.

The new Control Points at the north and south end of the passing siding are proposed to have universal crossovers to allow trains on either of the existing tracks to access the new passing siding.

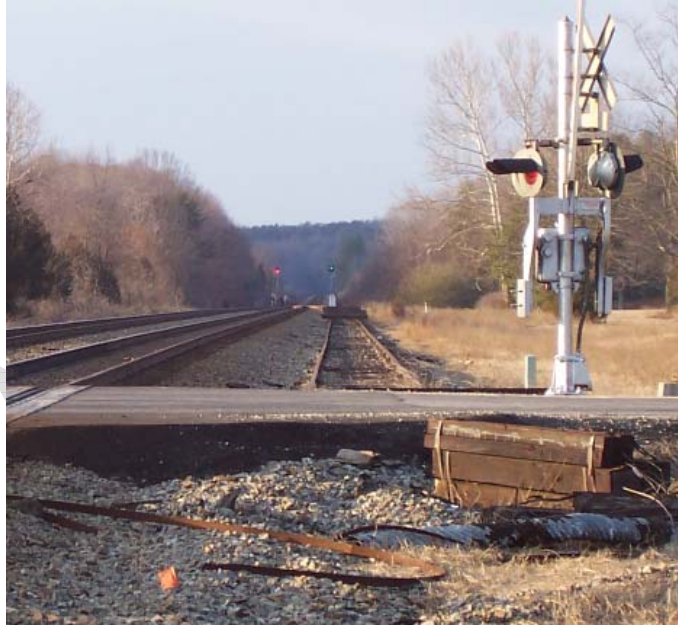
b. Guinea Passing Siding MP 44.4 to MP 47.4

The Guinea Passing Siding is located on the east side of the RF&P Mainline. It utilizes portions of the existing and abandoned siding at Guinea. The south end of the siding also uses abandoned segments of roadbed at Woodard.

The new Control Points at the north and south end of the passing siding are proposed to have universal crossovers to allow trains on either of the existing tracks to access the new passing siding.
